APOLLO VICTORIA THEATRE
1:50 WHEN PLOTTED ON A3

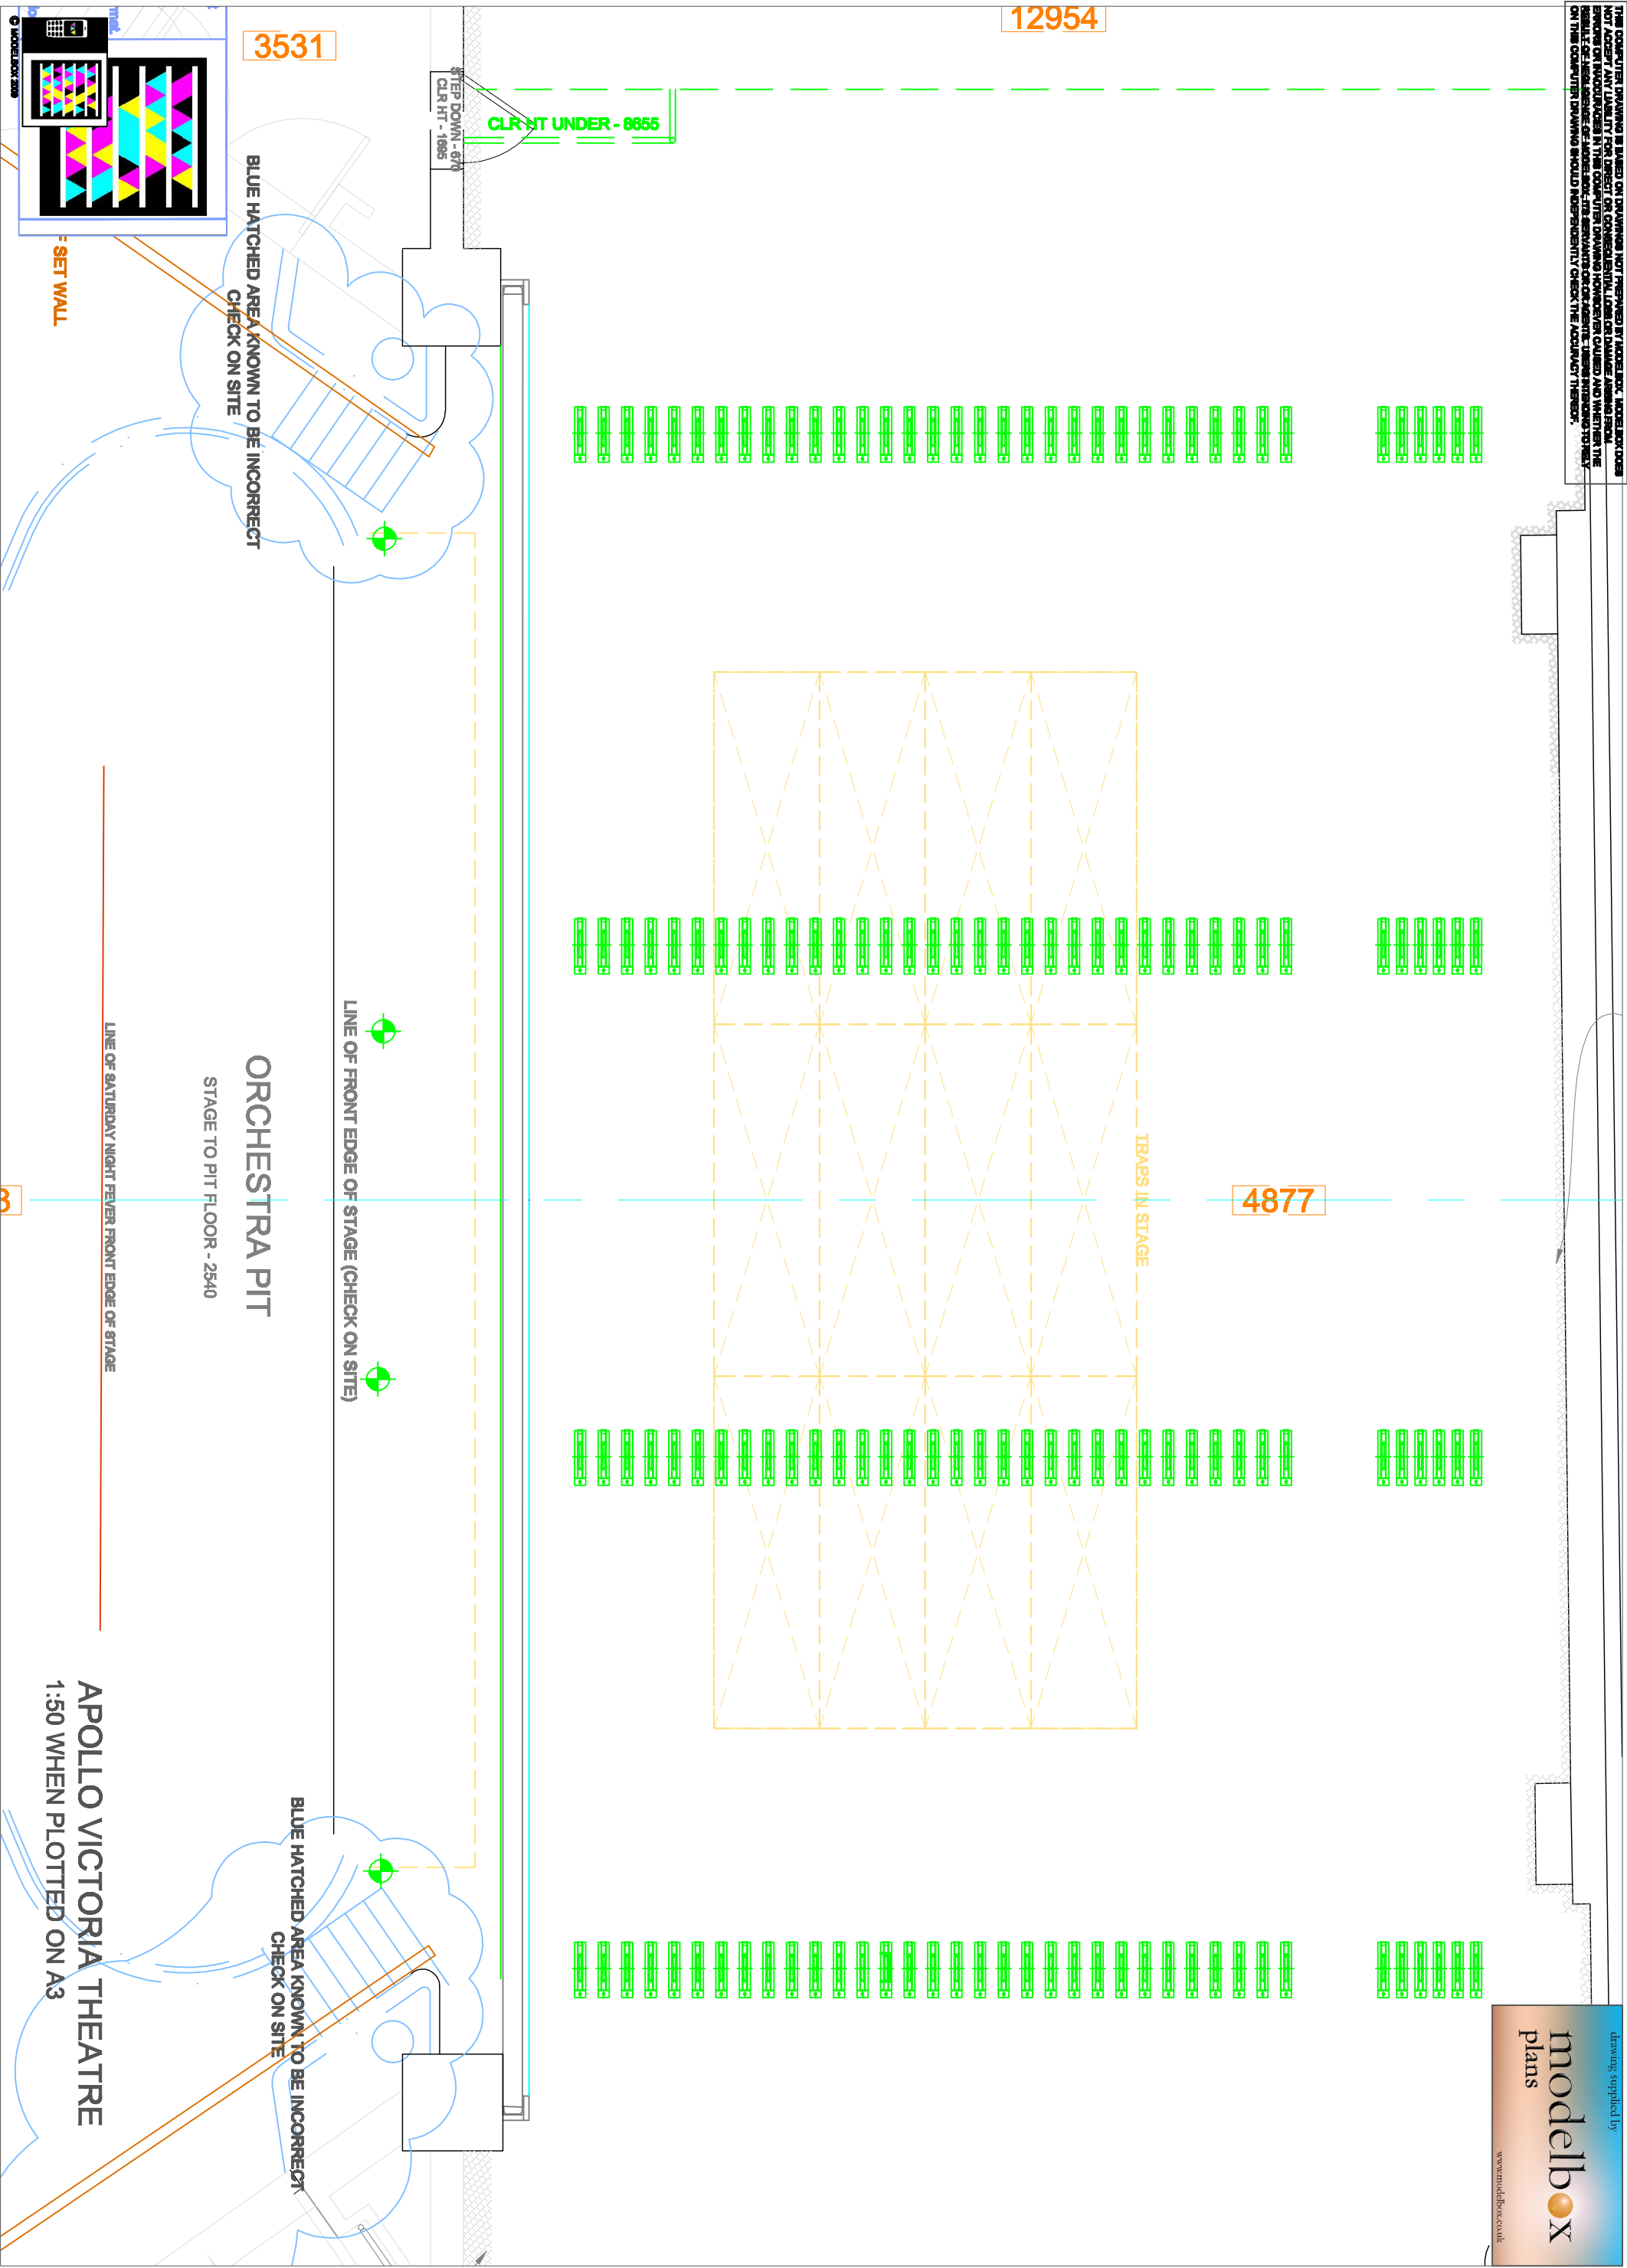
CLR HT UNDER - 8655

STEP DOWN - 670
CLR HT - 1085

BLUE HATCHED AREA KNOWN TO BE INCORRECT
CHECK ON SITE

LINE OF FRONT EDGE OF STAGE (CHECK ON SITE)

ORCHESTRA PIT

STAGE TO PIT FLOOR - 2540

LINE OF SATURDAY NIGHT FEVER FRONT EDGE OF STAGE

TRAPS IN STAGE
